HOME REPORT

Energy Performance Certificate (EPC)

2A LOCHRYAN STREET, STRANRAER, DG9 7HR

SINGLE SURVEY

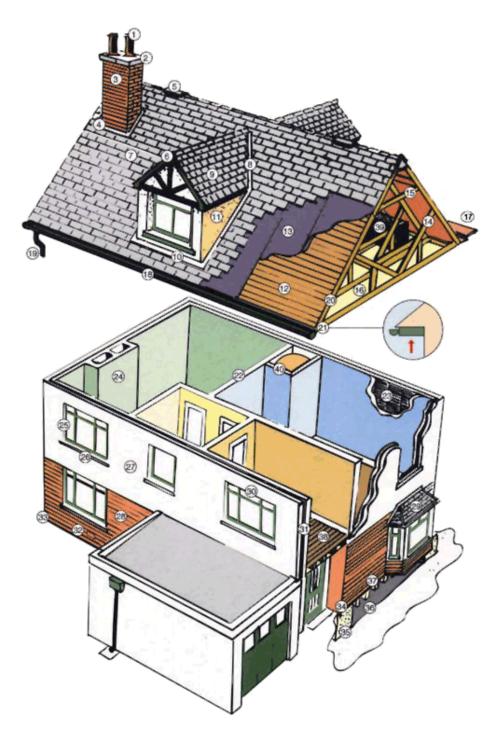
Sectional Diagram showing elements of a typical house

Reference may be made in this report to some or all of the above component parts of the property. This diagram may assist you in locating and understanding these items.

- 1) Chimney pots
- 2) Coping stone
- 3) Chimney head
- 4 Flashing
- 5 Ridge ventilation
- 6) Ridge board
- 7) Slates / tiles
- 8 Valley guttering
- 9 Dormer projection
- 10 Dormer flashing
- 11) Dormer cheeks
- (12) Sarking
- 13) Roof felt
- (14) Trusses
- 15) Collar
- (16) Insulation
- (17) Parapet gutter
- (18) Eaves guttering
- (19) Rainwater downpipe
- 20) Verge boards/skews
- 21) Soffit boards
- 22) Partition wall
- 23) Lath / plaster
- 24) Chimney breast
- (25) Window pointing
- 6) Window sills
- 27) Rendering
- (28) Brickwork / pointing
- 29 Bay window projection
- (30) Lintels
- (31) Cavity walls / wall ties
- 32) Subfloor ventilator
- 33) Damp proof course
- 34) Base course
- 35) Foundations
- 36) Solum
- 37) Floor joists
- 38) Floorboards
- 39) Water tank
- 40 Hot water tank
