HOME REPORT

WELLBROOK
23 SUN STREET
STRANRAER
DG9 7JL

Energy Performance Certificate (EPC)

WELLBROOK, 23 SUN STREET, STRANRAER, DG9 7JL

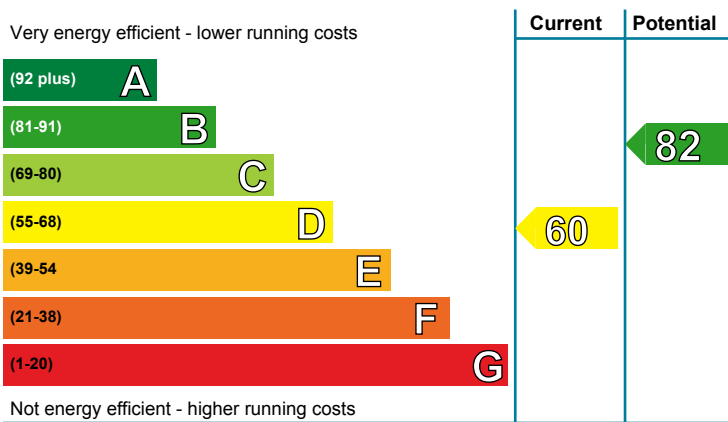
Energy Efficiency Rating

This graph shows the current efficiency of your home, taking into account both energy efficiency and fuel costs. The higher this rating, the lower your fuel bills are likely to be.

Your current rating is **band D (60)**. The average rating for EPCs in Scotland is **band D (61)**.

The potential rating shows the effect of undertaking all of the improvement measures listed within your recommendations report.
