# HOME REPORT

1A/B Hill Street  
Portpatrick  
DG9 8JX

# Energy Performance Certificate (EPC)

1A/B Hill Street, Portpatrick, DG9 8JX

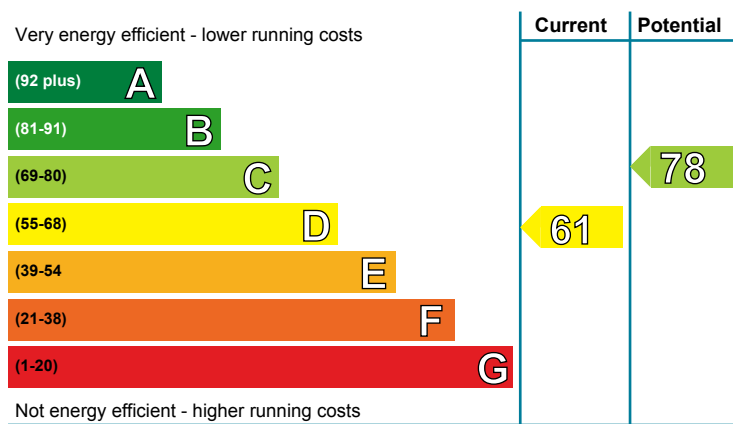
## Energy Efficiency Rating

This graph shows the current efficiency of your home, taking into account both energy efficiency and fuel costs. The higher this rating, the lower your fuel bills are likely to be.

Your current rating is **band D (61)**. The average rating for EPCs in Scotland is **band D (61)**.

The potential rating shows the effect of undertaking all of the improvement measures listed within your recommendations report.

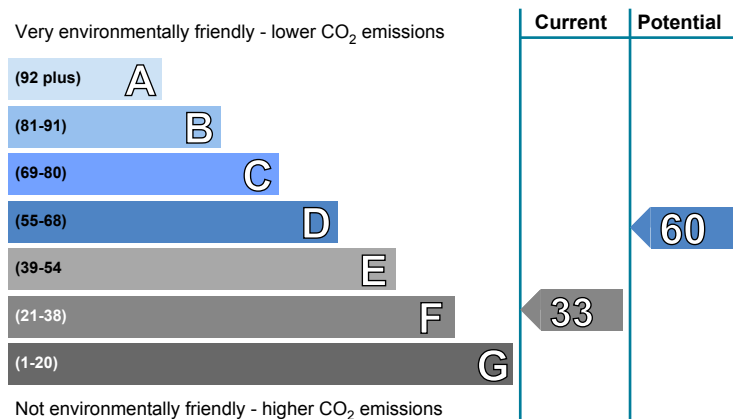
## Environmental Impact (CO<sub>2</sub>) Rating

This graph shows the effect of your home on the environment in terms of carbon dioxide (CO<sub>2</sub>) emissions. The higher the rating, the less impact it has on the environment.

Your current rating is **band F (33)**. The average rating for EPCs in Scotland is **band D (59)**.

The potential rating shows the effect of undertaking all of the improvement measures listed within your recommendations report.
