Single Survey

survey report on:

Property address	9, McCormack Gardens, Stranraer, Dumfries and Galloway, DG9 7JB
-------------------------	---

Prepared by	Graham + Sibbald
--------------------	------------------

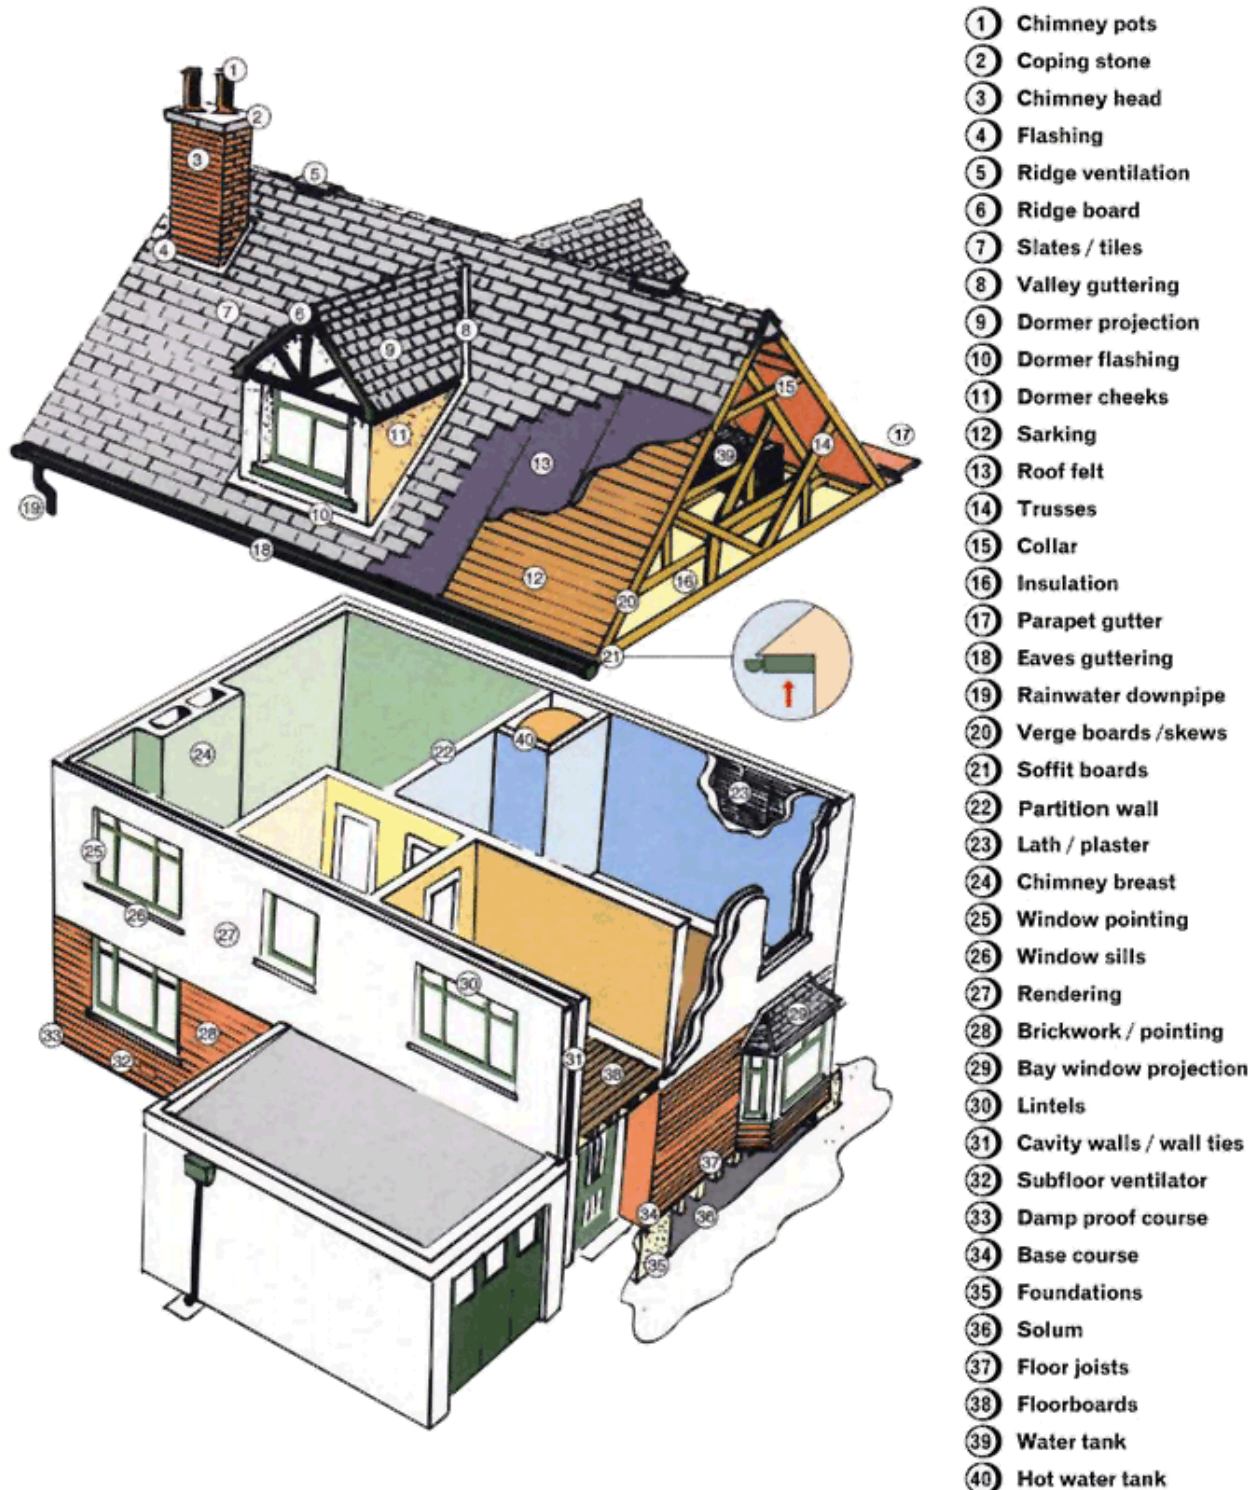
Sectional Diagram showing elements of a typical house

Reference may be made in this report to some or all of the above component parts of the property. This diagram may assist you in locating and understanding these items.
