Home Report

Scottish Single Survey

Single Survey

Property address	27 Motehill Glenluce Newton Stewart DG8 0QE
Customer	Leona Lloyd
Customer address	27 Motehill Glenluce Newton Stewart DG8 0QE
Prepared by	Shepherd Chartered Surveyors
Date of inspection	02/10/2024

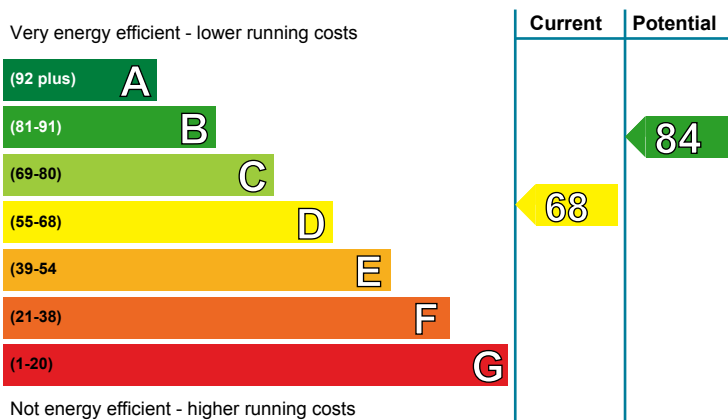
Energy Efficiency Rating

This graph shows the current efficiency of your home, taking into account both energy efficiency and fuel costs. The higher this rating, the lower your fuel bills are likely to be.

Your current rating is **band D (68)**. The average rating for EPCs in Scotland is **band D (61)**.

The potential rating shows the effect of undertaking all of the improvement measures listed within your recommendations report.
