HOME REPORT

Energy Performance Certificate (EPC)

2 MILLFIELD ROAD, PORTPATRICK, STRANRAER, DG9 8UB

Dwelling type: Detached bungalow
Date of assessment: 30 July 2024
Date of certificate: 30 July 2024
Total floor area: 81 m²
Primary Energy Indicator: 258 kWh/m²/year

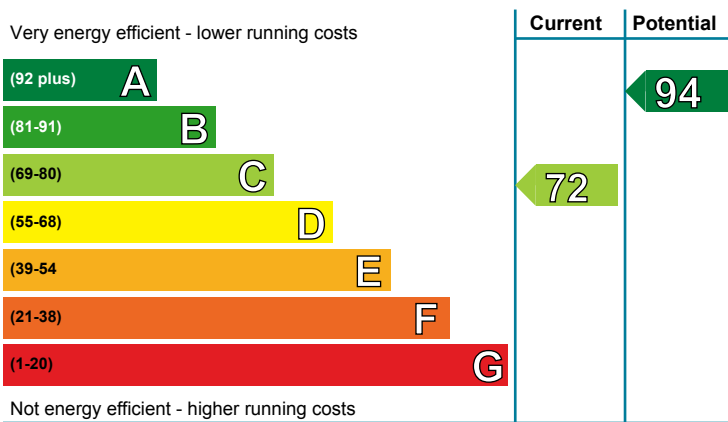
Energy Efficiency Rating

This graph shows the current efficiency of your home, taking into account both energy efficiency and fuel costs. The higher this rating, the lower your fuel bills are likely to be.

Your current rating is **band C (72)**. The average rating for EPCs in Scotland is **band D (61)**.

The potential rating shows the effect of undertaking all of the improvement measures listed within your recommendations report.

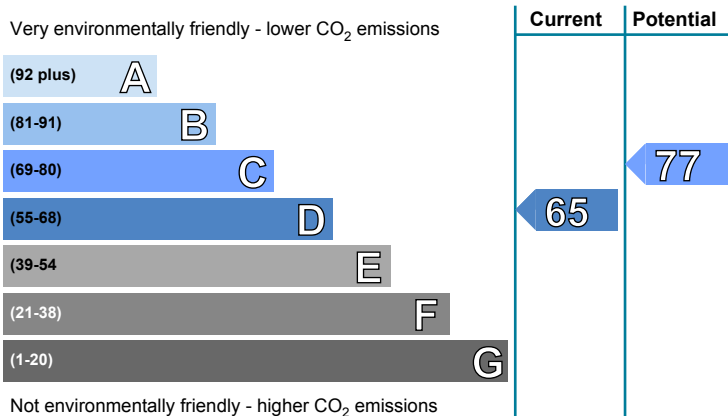
Environmental Impact (CO₂) Rating

This graph shows the effect of your home on the environment in terms of carbon dioxide (CO₂) emissions. The higher the rating, the less impact it has on the environment.

Your current rating is **band D (65)**. The average rating for EPCs in Scotland is **band D (59)**.

The potential rating shows the effect of undertaking all of the improvement measures listed within your recommendations report.
