HOME REPORT

ERNMAUR, 6A MAIN STREET, PORTPATRICK, STRANRAER, DG9 8JJ

Single Survey

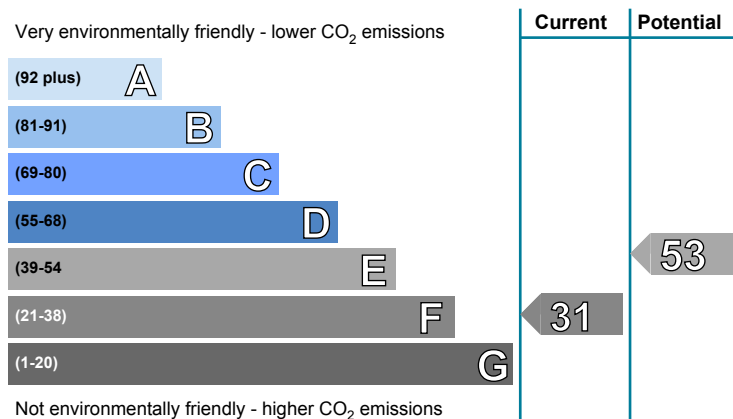
Environmental Impact (CO₂) Rating

This graph shows the effect of your home on the environment in terms of carbon dioxide (CO₂) emissions. The higher the rating, the less impact it has on the environment.

Your current rating is **band F (31)**. The average rating for EPCs in Scotland is **band D (59)**.

The potential rating shows the effect of undertaking all of the improvement measures listed within your recommendations report.
