HOME REPORT

Energy Performance Certificate (EPC)

72 BELMONT ROAD, STRANRAER, DG9 7BB

Dwelling type: End-terrace house
Date of assessment: 18 February 2025
Date of certificate: 18 February 2025
Total floor area: 63 m²
Primary Energy Indicator: 1032 kWh/m²/year

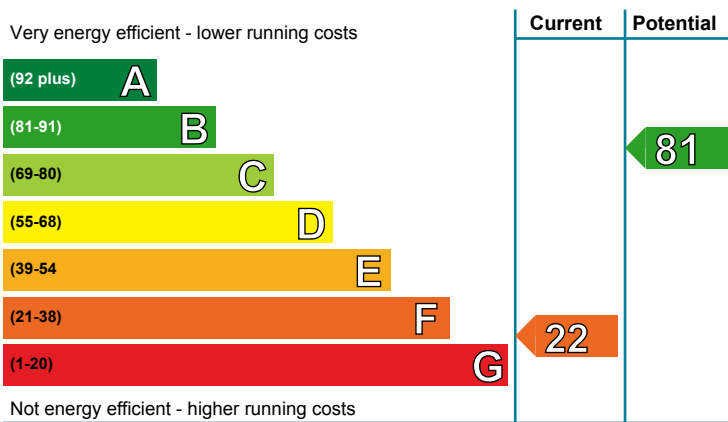
Energy Efficiency Rating

This graph shows the current efficiency of your home, taking into account both energy efficiency and fuel costs. The higher this rating, the lower your fuel bills are likely to be.

Your current rating is **band F (22)**. The average rating for EPCs in Scotland is **band D (61)**.

The potential rating shows the effect of undertaking all of the improvement measures listed within your recommendations report.

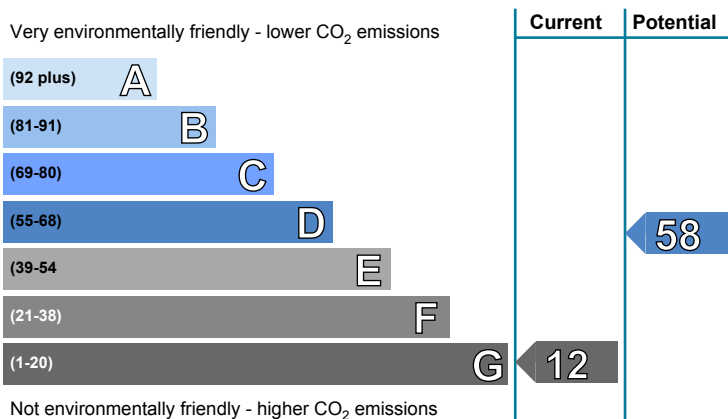
Environmental Impact (CO₂) Rating

This graph shows the effect of your home on the environment in terms of carbon dioxide (CO₂) emissions. The higher the rating, the less impact it has on the environment.

Your current rating is **band G (12)**. The average rating for EPCs in Scotland is **band D (59)**.

The potential rating shows the effect of undertaking all of the improvement measures listed within your recommendations report.
