HOME REPORT

9 LEWIS STREET
STRANRAER
DG9 7AB

Single Survey

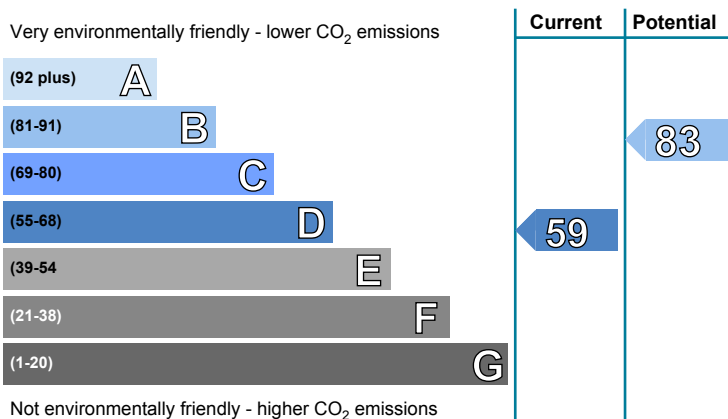
Environmental Impact (CO₂) Rating

This graph shows the effect of your home on the environment in terms of carbon dioxide (CO₂) emissions. The higher the rating, the less impact it has on the environment.

Your current rating is **band D (59)**. The average rating for EPCs in Scotland is **band D (59)**.

The potential rating shows the effect of undertaking all of the improvement measures listed within your recommendations report.
