HOME REPORT

Bridge Cottage, Dunragit, DG9 8QB

SINGLE SURVEY

survey report on:

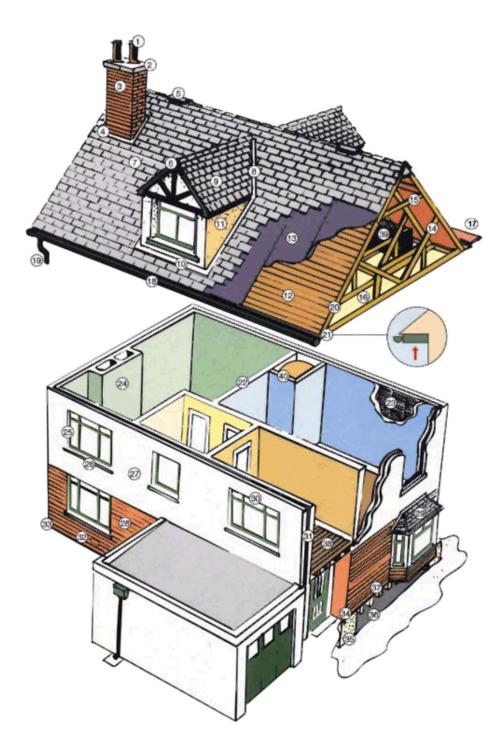
Sectional Diagram showing elements of a typical house

Reference may be made in this report to some or all of the above component parts of the property. This diagram may assist you in locating and understanding these items.

- 1) Chimney pots
- 2 Coping stone
- 3) Chimney head
- 4 Flashing
- 5) Ridge ventilation
- 6 Ridge board
- 7) Slates / tiles
- 8 Valley guttering
- 9 Dormer projection
- 10 Dormer flashing
- 11) Dormer cheeks
- (12) Sarking
- (13) Roof felt
- (14) Trusses
- (15) Collar
- 16) Insulation
- (17) Parapet gutter
- 18) Eaves guttering
- Rainwater downpipe
- 20) Verge boards/skews
- 21) Soffit boards
- 22) Partition wall
- 23) Lath / plaster
- 24) Chimney breast
- 25) Window pointing
- 6) Window sills
- 27) Rendering
- (28) Brickwork / pointing
- 29) Bay window projection
- 30 Lintels
- (31) Cavity walls / wall ties
- 32) Subfloor ventilator
- 33) Damp proof course
- 34) Base course
- 35) Foundations
- 36) Solum
- 37) Floor joists
- 38) Floorboards
- 39) Water tank
- 40) Hot water tank
