HOME REPORT

CLUNY, 18A LARG ROAD, STRANRAER, DG9 0JE

SINGLE SURVEY

survey report on:

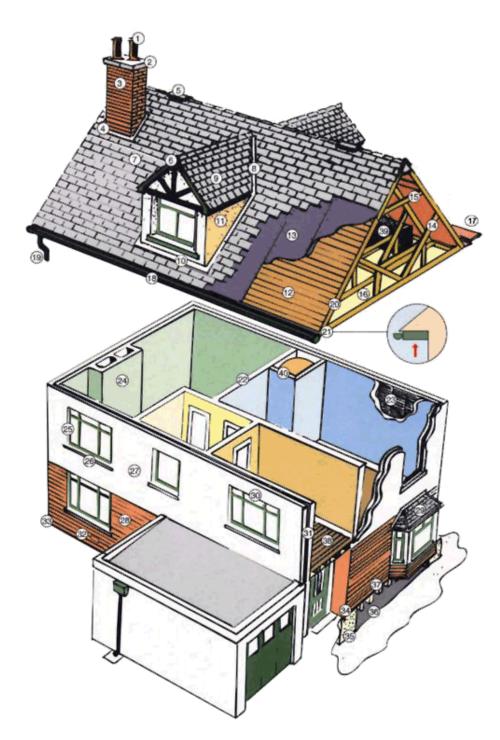
Sectional Diagram showing elements of a typical house

Reference may be made in this report to some or all of the above component parts of the property. This diagram may assist you in locating and understanding these items.

- 1) Chimney pots
- 2) Coping stone
- 3) Chimney head
- 4 Flashing
- 5 Ridge ventilation
- 6 Ridge board
- 7) Slates / tiles
- 8 Valley guttering
- 9 Dormer projection
- 10 Dormer flashing
- 11) Dormer cheeks
- 12) Sarking
- (13) Roof felt
- (14) Trusses
- (15) Collar
- 16) Insulation
- (17) Parapet gutter
- (18) Eaves guttering
- 19) Rainwater downpipe
- 20) Verge boards/skews
- 21) Soffit boards
- 22) Partition wall
- 23) Lath / plaster
- 24) Chimney breast
- (25) Window pointing
- 6) Window sills
- 27) Rendering
- (28) Brickwork / pointing
- 29) Bay window projection
- 30 Lintels
- (31) Cavity walls / wall ties
- 32) Subfloor ventilator
- (33) Damp proof course
- 34) Base course
- 35) Foundations
- 36) Solum
- 37) Floor joists
- 38) Floorboards
- 39) Water tank
- 40 Hot water tank
