HOME REPORT

Energy Performance Certificate (EPC)

INVERSHEIL, 63 SHEUCHAN STREET, STRANRAER, DG9 0EA

Dwelling type: Mid-terrace house
Date of assessment: 09 October 2023
Date of certificate: 11 October 2023
Total floor area: 115 m²
Primary Energy Indicator: 175 kWh/m²/year

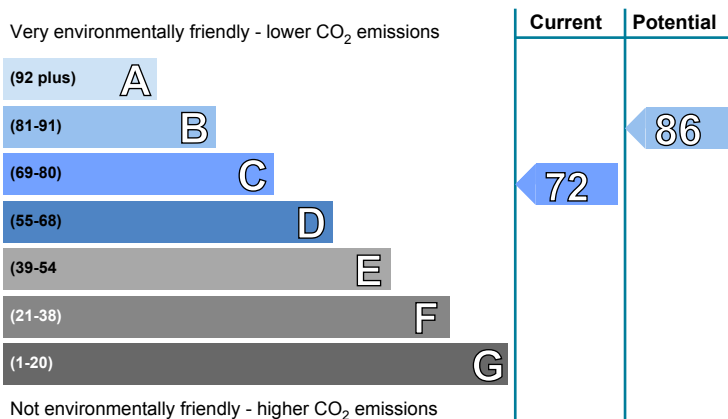
Environmental Impact (CO₂) Rating

This graph shows the effect of your home on the environment in terms of carbon dioxide (CO₂) emissions. The higher the rating, the less impact it has on the environment.

Your current rating is **band C (72)**. The average rating for EPCs in Scotland is **band D (59)**.

The potential rating shows the effect of undertaking all of the improvement measures listed within your recommendations report.
