HOME REPORT

MYRTLE BANK EDINBURGH ROAD

STRANRAER
DG9 7HD

Single Survey

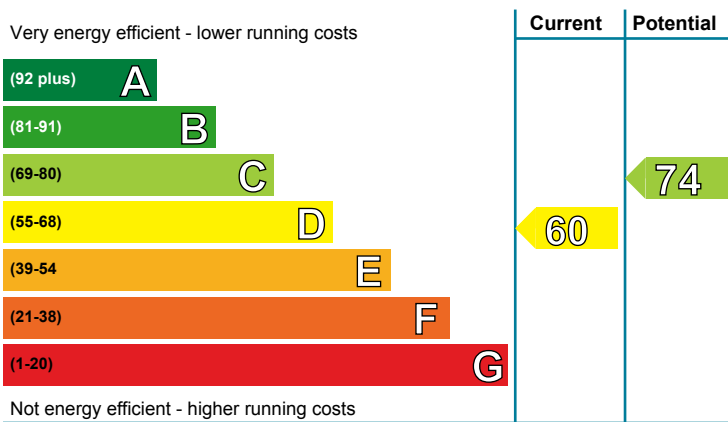
Energy Efficiency Rating

This graph shows the current efficiency of your home, taking into account both energy efficiency and fuel costs. The higher this rating, the lower your fuel bills are likely to be.

Your current rating is **band D (60)**. The average rating for EPCs in Scotland is **band D (61)**.

The potential rating shows the effect of undertaking all of the improvement measures listed within your recommendations report.

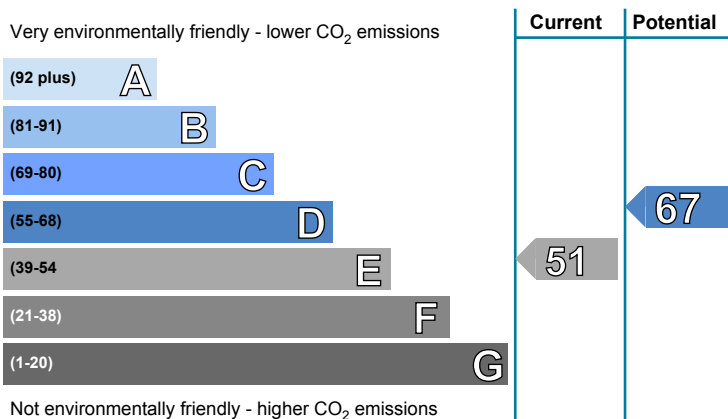
Environmental Impact (CO₂) Rating

This graph shows the effect of your home on the environment in terms of carbon dioxide (CO₂) emissions. The higher the rating, the less impact it has on the environment.

Your current rating is **band E (51)**. The average rating for EPCs in Scotland is **band D (59)**.

The potential rating shows the effect of undertaking all of the improvement measures listed within your recommendations report.
