HOME REPORT

PORT BEGG COTTAGE, STRANRAER, DG9 0PE

Dwelling type: Detached bungalow
Date of assessment: 22 January 2025
Date of certificate: 27 January 2025
Total floor area: 158 m²
Primary Energy Indicator: 210 kWh/m²/year

Single Survey

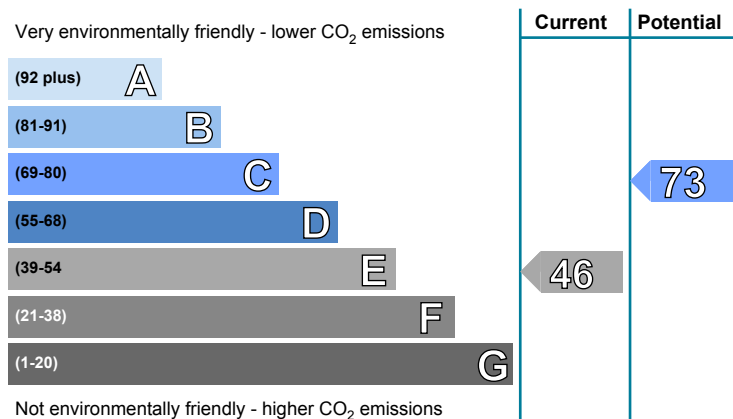
Environmental Impact (CO₂) Rating

This graph shows the effect of your home on the environment in terms of carbon dioxide (CO₂) emissions. The higher the rating, the less impact it has on the environment.

Your current rating is **band E (46)**. The average rating for EPCs in Scotland is **band D (59)**.

The potential rating shows the effect of undertaking all of the improvement measures listed within your recommendations report.
