HOME REPORT

31 GLENWELL AVENUE
STRANRAER
DG9 7BA

Energy Performance Certificate (EPC)

31 GLENWELL AVENUE, STRANRAER, DG9 7BA

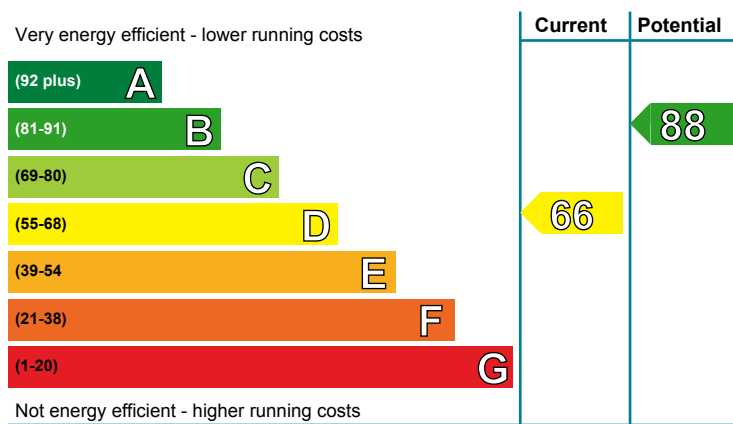
Energy Efficiency Rating

This graph shows the current efficiency of your home, taking into account both energy efficiency and fuel costs. The higher this rating, the lower your fuel bills are likely to be.

Your current rating is **band D (66)**. The average rating for EPCs in Scotland is **band D (61)**.

The potential rating shows the effect of undertaking all of the improvement measures listed within your recommendations report.

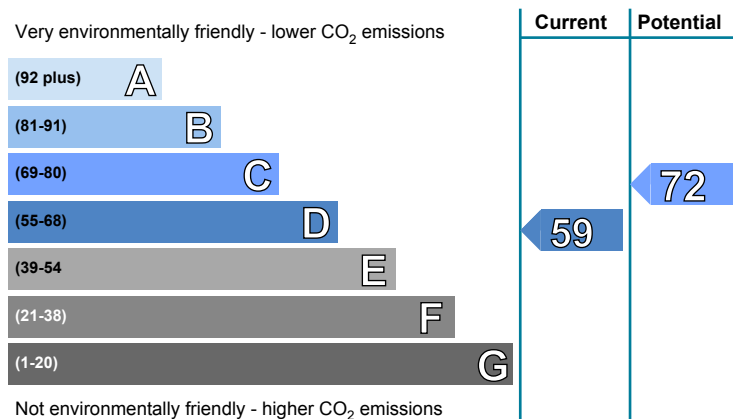
Environmental Impact (CO₂) Rating

This graph shows the effect of your home on the environment in terms of carbon dioxide (CO₂) emissions. The higher the rating, the less impact it has on the environment.

Your current rating is **band D (59)**. The average rating for EPCs in Scotland is **band D (59)**.

The potential rating shows the effect of undertaking all of the improvement measures listed within your recommendations report.

The average Scottish household produces about 6 tonnes of carbon dioxide every year. Based on this assessment, heating and lighting this home currently produces approximately 5.2 tonnes of carbon dioxide every year. Adopting recommendations in this report can reduce emissions and protect the environment. If you were to install all of these recommendations this could reduce emissions by 1.5 tonnes per year. You could reduce emissions even more by switching to renewable energy sources.
