SINGLE SURVEY

Single Survey

Survey report on:

| Selling address | 3 Colfin Cottages Bogside Portpatrick, Stranraer DG9 9AF |

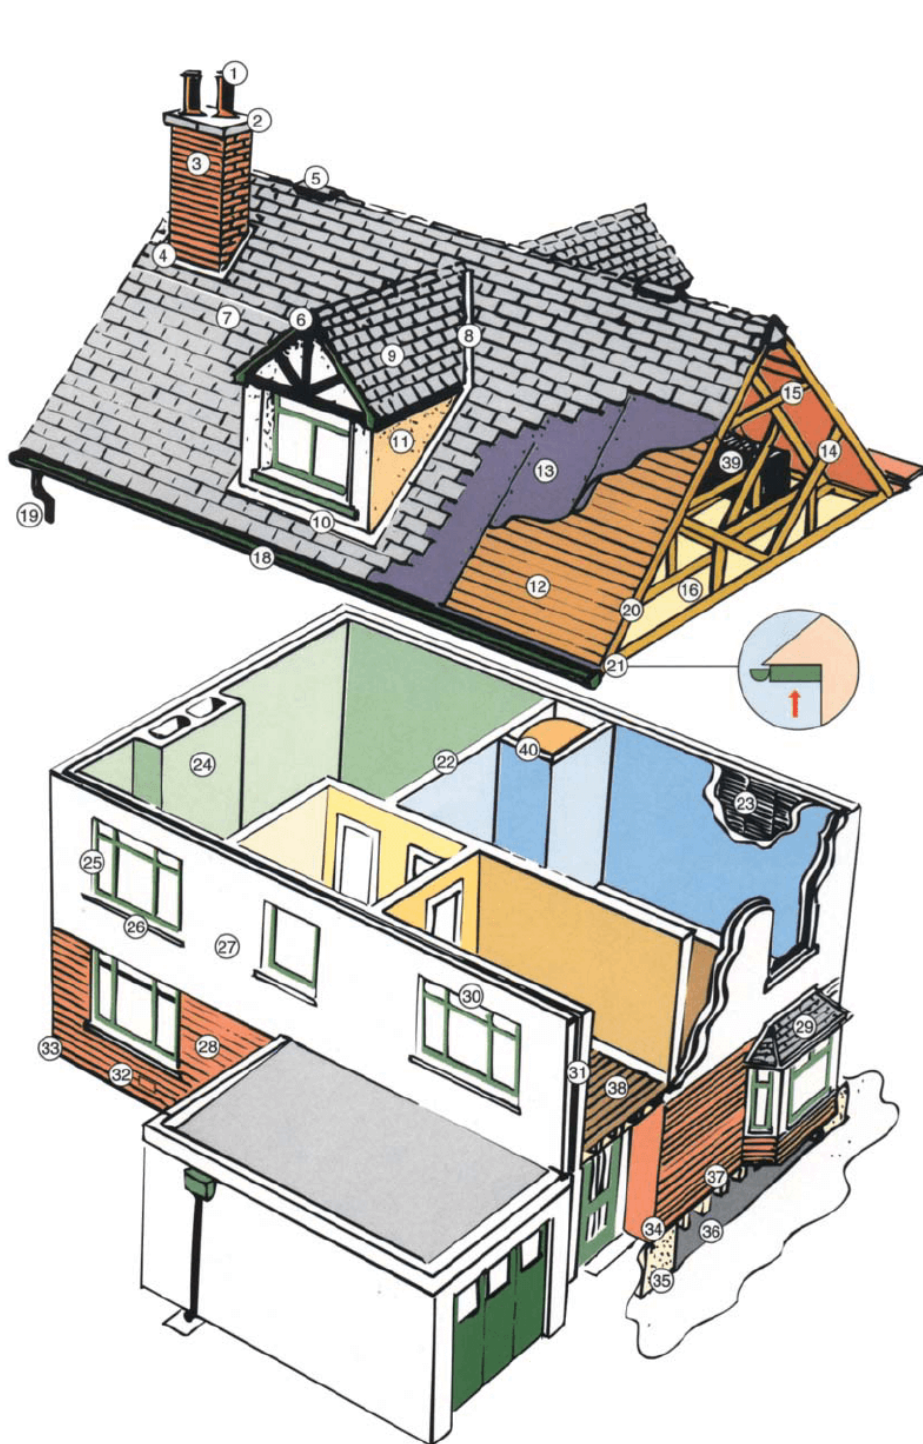
Sectional Diagram showing elements of a typical house

- ① Chimney pots
- ② Coping stone
- ③ Chimney head
- ④ Flashing
- ⑤ Ridge ventilation
- ⑥ Ridge board
- ⑦ Slates / tiles
- ⑧ Valley guttering
- ⑨ Dormer projection
- ⑩ Dormer flashing
- ⑪ Dormer cheeks
- ⑫ Sarking
- ⑬ Roof felt
- ⑭ Trusses
- ⑮ Collar
- ⑯ Insulation
- ⑰ Parapet gutter
- ⑱ Eaves guttering
- ⑲ Rainwater downpipe
- ⑳ Verge boards /skews
- ㉑ Soffit boards
- ㉒ Partiton wall
- ㉓ Lath / plaster
- ㉔ Chimney breast
- ㉕ Window pointing
- ㉖ Window sills
- ㉗ Rendering
- ㉘ Brickwork / pointing
- ㉙ Bay window projection
- ㉚ Lintels
- ㉛ Cavity walls / wall ties
- ㉜ Subfloor ventilator
- ㉝ Damp proof course
- ㉞ Base course
- ㉟ Foundations
- ㊱ Solum
- ㊲ Floor joists
- ㊳ Floorboards
- ㊴ Water tank
- ㊵ Hot water tank

Reference may be made in this report to some or all of the above component parts of the property. This diagram may assist you in locating and understanding these items.
